Description and Results	 2012 Reactor Pressure Vessel Base Material Exams: Examinations were performed in the area illustrated in Figure 3 during the 2012 Outage at KKM. Straight and angle beam examinations were performed in a 500 mm wide section of the reactor pressure vessel, located at 22° Az, extending from the flange elevation down to the shroud support plate. Limitations that were encountered in this scan area include the feedwater spargers, core spray piping, jet pump diffuser and shroud support plate. Examination Results: No reportable indications were found during the straight beam examinations. No reportable indications were found during the angle beam examinations. Geometric indications were found during the angle beam examinations. Geometric indications were found during the RPV flange, OD insulation support bracket attachments, vessel circumferential welds, shell course thickness transitions, and ID clad roll (full V path). Indications from water coupled signals from the examination scanner and entry surface noise were evaluated and determined to be non-relevant. The 2012 examination data shows that there were no fabrication type reflectors or other adverse conditions

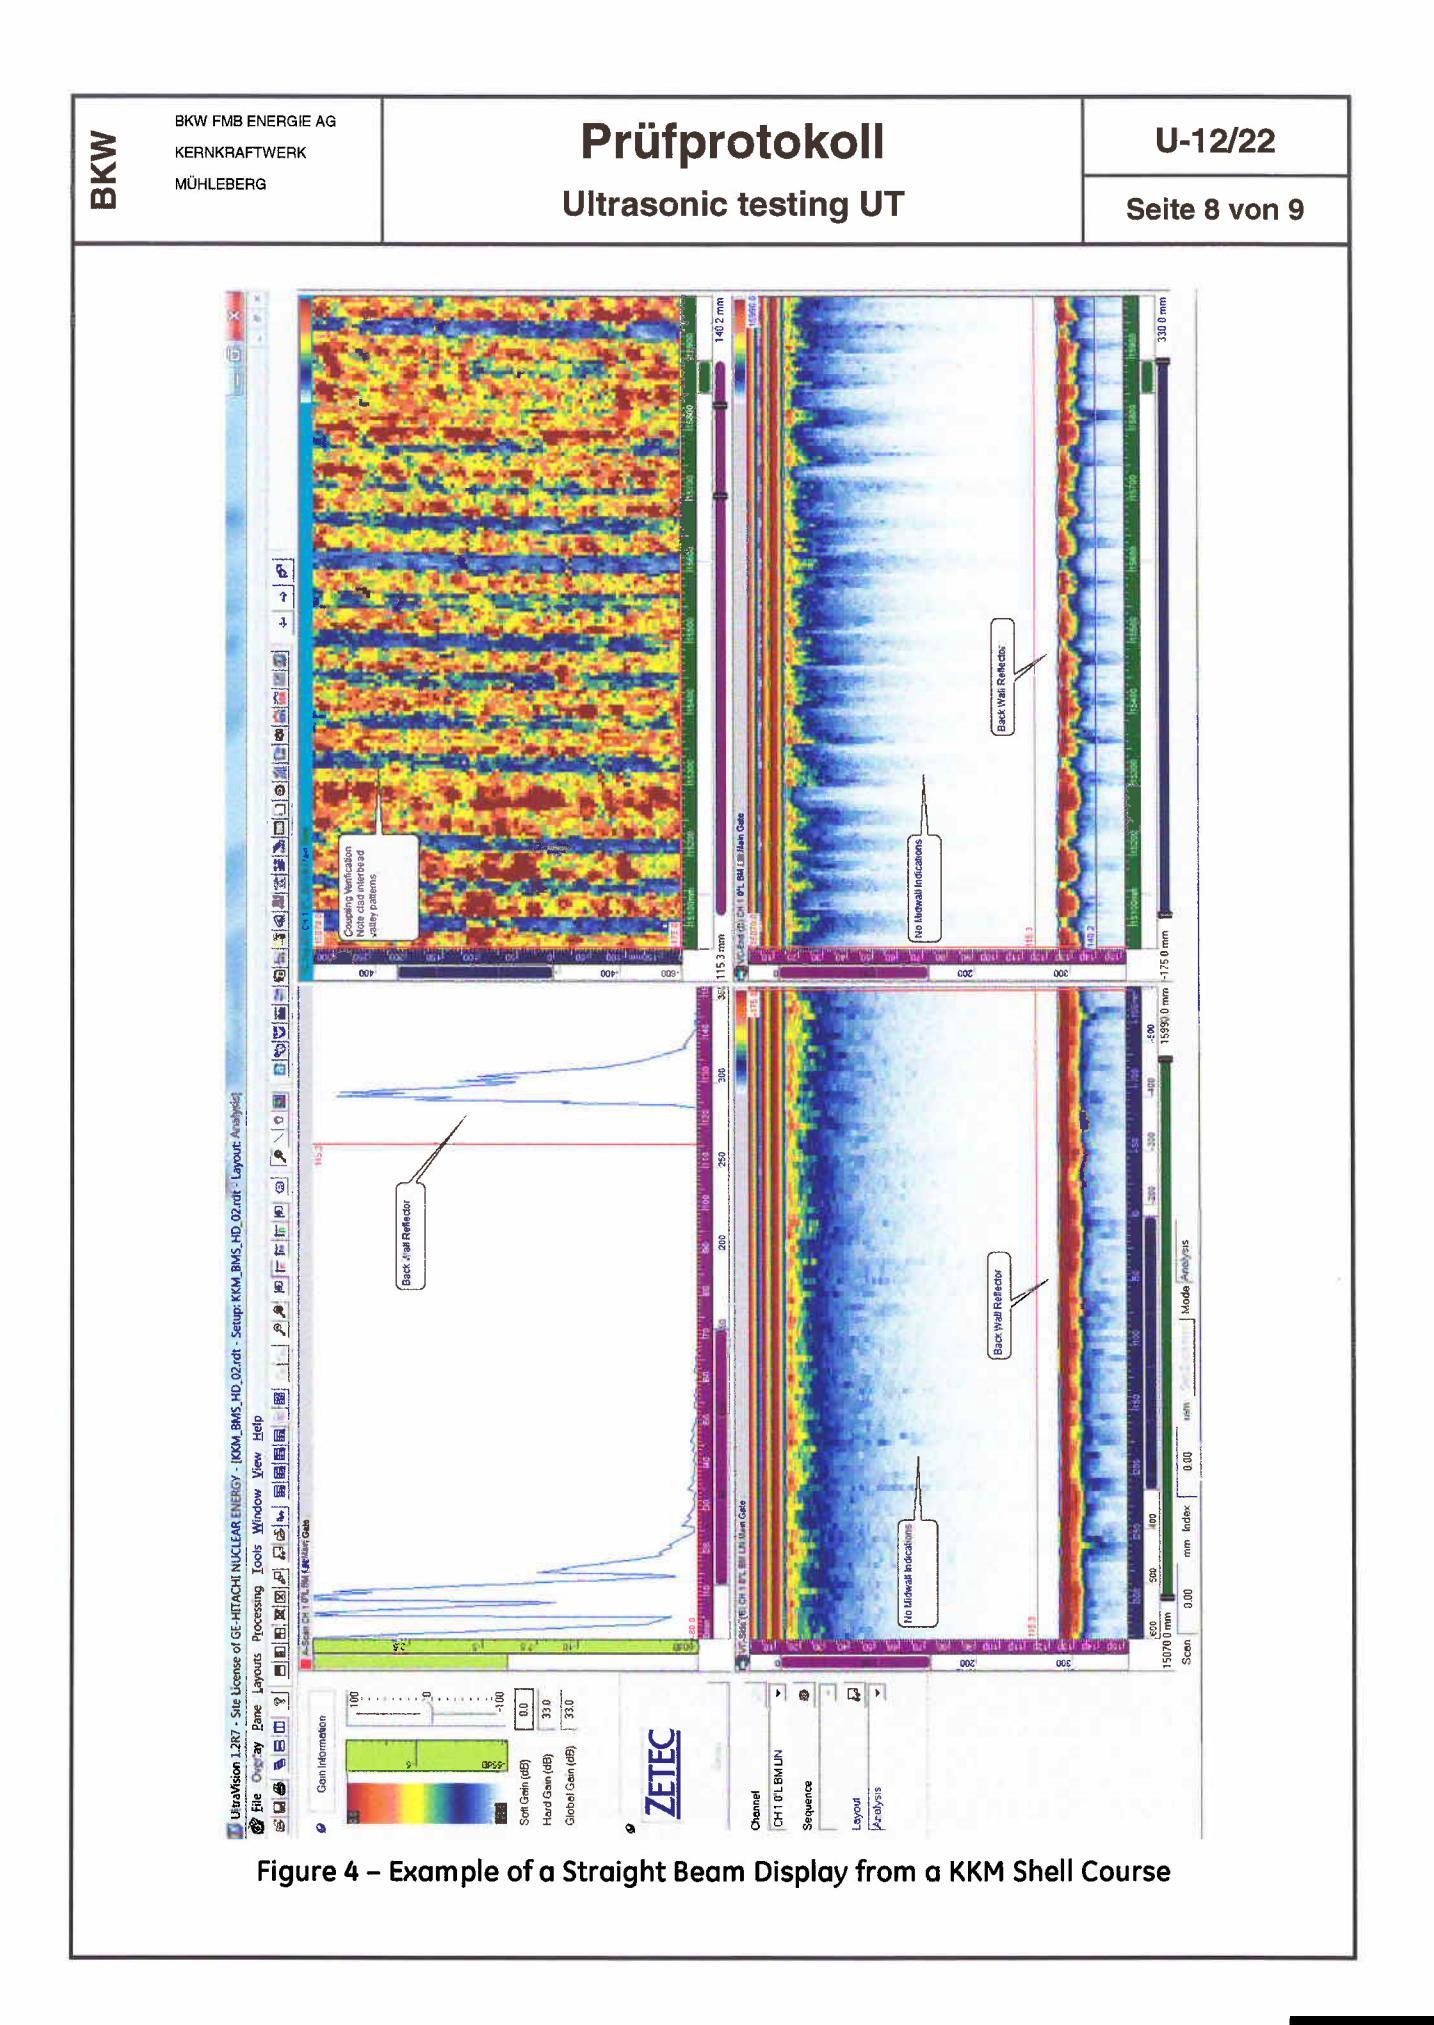
GE Hitachi inspected an area 500 mm wide centered on the 22° Azimuth of the vessel. The examination was performed from the full accessible length of the vessel extending from the flange surface to the shroud support plate reference Figure 3. This examination area passes through all five shell courses of the vessel and represents all fluence conditions experienced by the vessel in service. Scanning of this length was limited due to the feedwater spargers, core spray piping, jet pump diffusers and shroud support plate.

Coverage Achieved (Figure 3)

85%	Shell Course 1 (V1 to V2)	Scanning was limited due to the shroud support plate and jet pump diffusers.
100%	Shell Course 2 (V2 to V3)	Scanning was not limited.
100%	Shell Course 3 (V3 to V4)	Scanning was not limited.
73%	Shell Course 4 (V4 to V5)	Scanning was limited due to the feedwater spargers and core spray piping.
100%	Shell Course 5 (V5 to V6)	Scanning was not limited.
